# 235635 Repair Kit

For Model 223587 and 223842  
Severe-Duty Displacement Pump

406136F

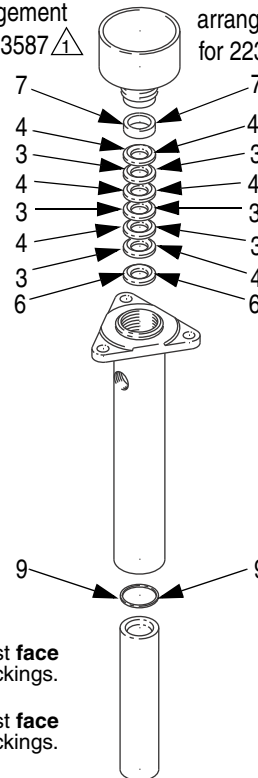
Throat packing arrangement for 223587

Throat packing arrangement for 223842

Lips of **throat** packings must **face down**. Lubricate packings.

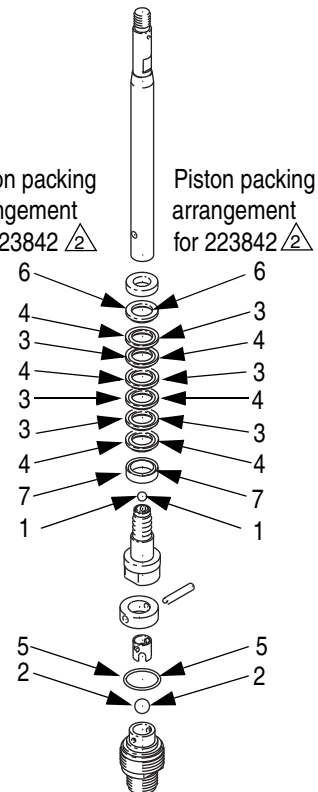
Piston packing arrangement for 223842

Lips of **piston** packings must **face up**. Lubricate packings.
